WOODRIDGE LAKE DAM

WARREN COUNTY, MISSOURI

MO 11005

## PHASE I INSPECTION REPORT NATIONAL DAM SAFETY PROGRAM

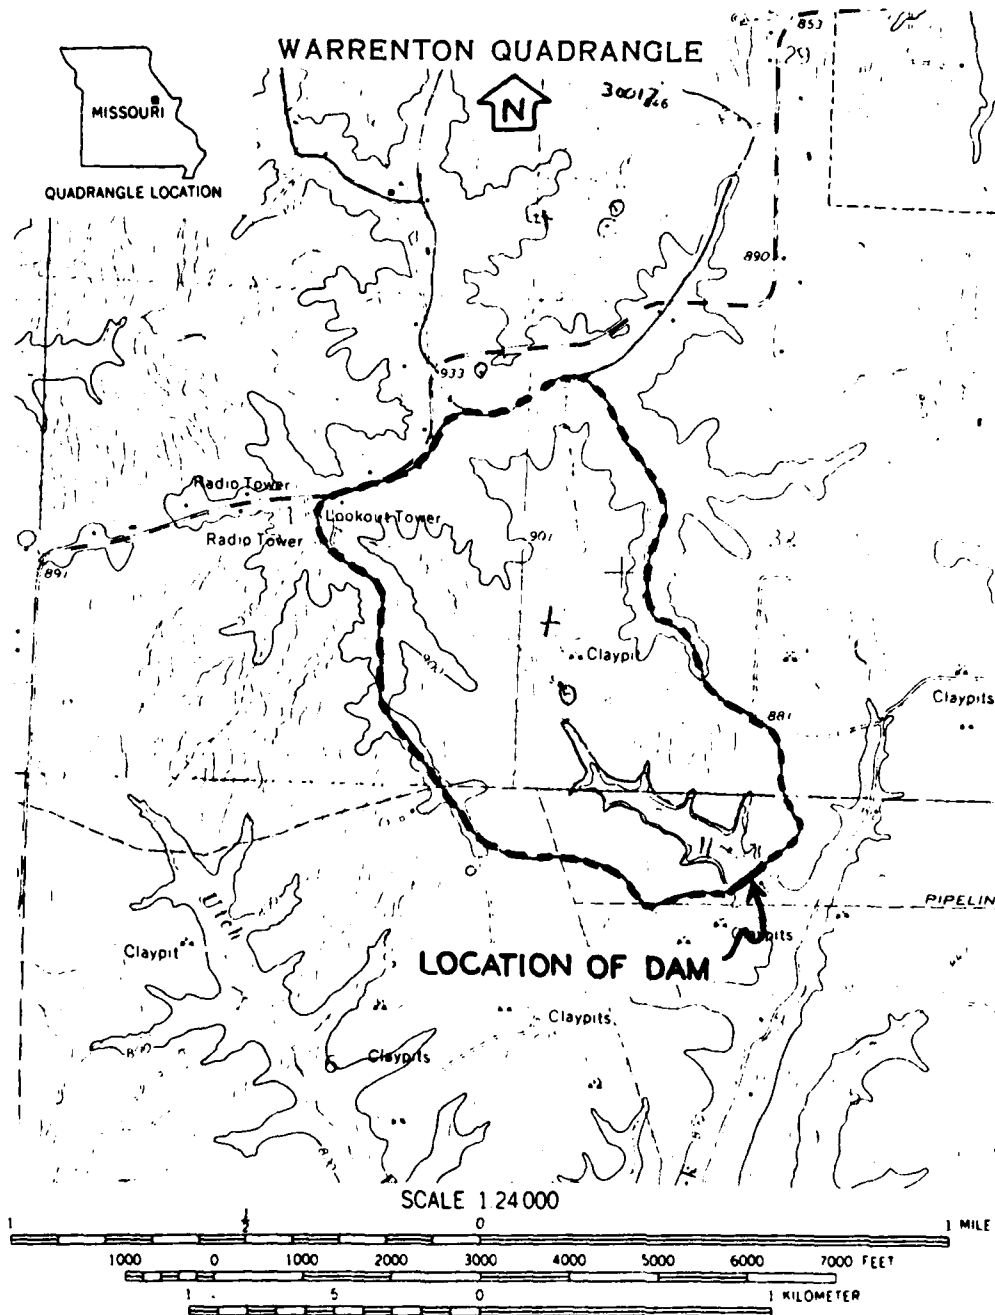
WOODRIDGE LAKE DAM (MO. 11005)  
DRAINAGE BASIN

The watershed area of the Woodridge Lake Dam upstream from the dam axis consists of approximately 420 acres. Most of the watershed area is wooded and covered with grass. Land gradients in the higher regions of the watershed average roughly 8 percent, and in the lower areas surrounding the reservoir average about 4 percent. The Woodridge Lake Reservoir is located on an unnamed tributary of Dry Creek. The reservoir is about 1000 feet upstream from the confluence of the unnamed tributary and Dry Creek. At its longest arm the watershed is approximately 1 1/4 mile long. A drainage map showing the watershed area is presented as Plate 1 in Appendix B.

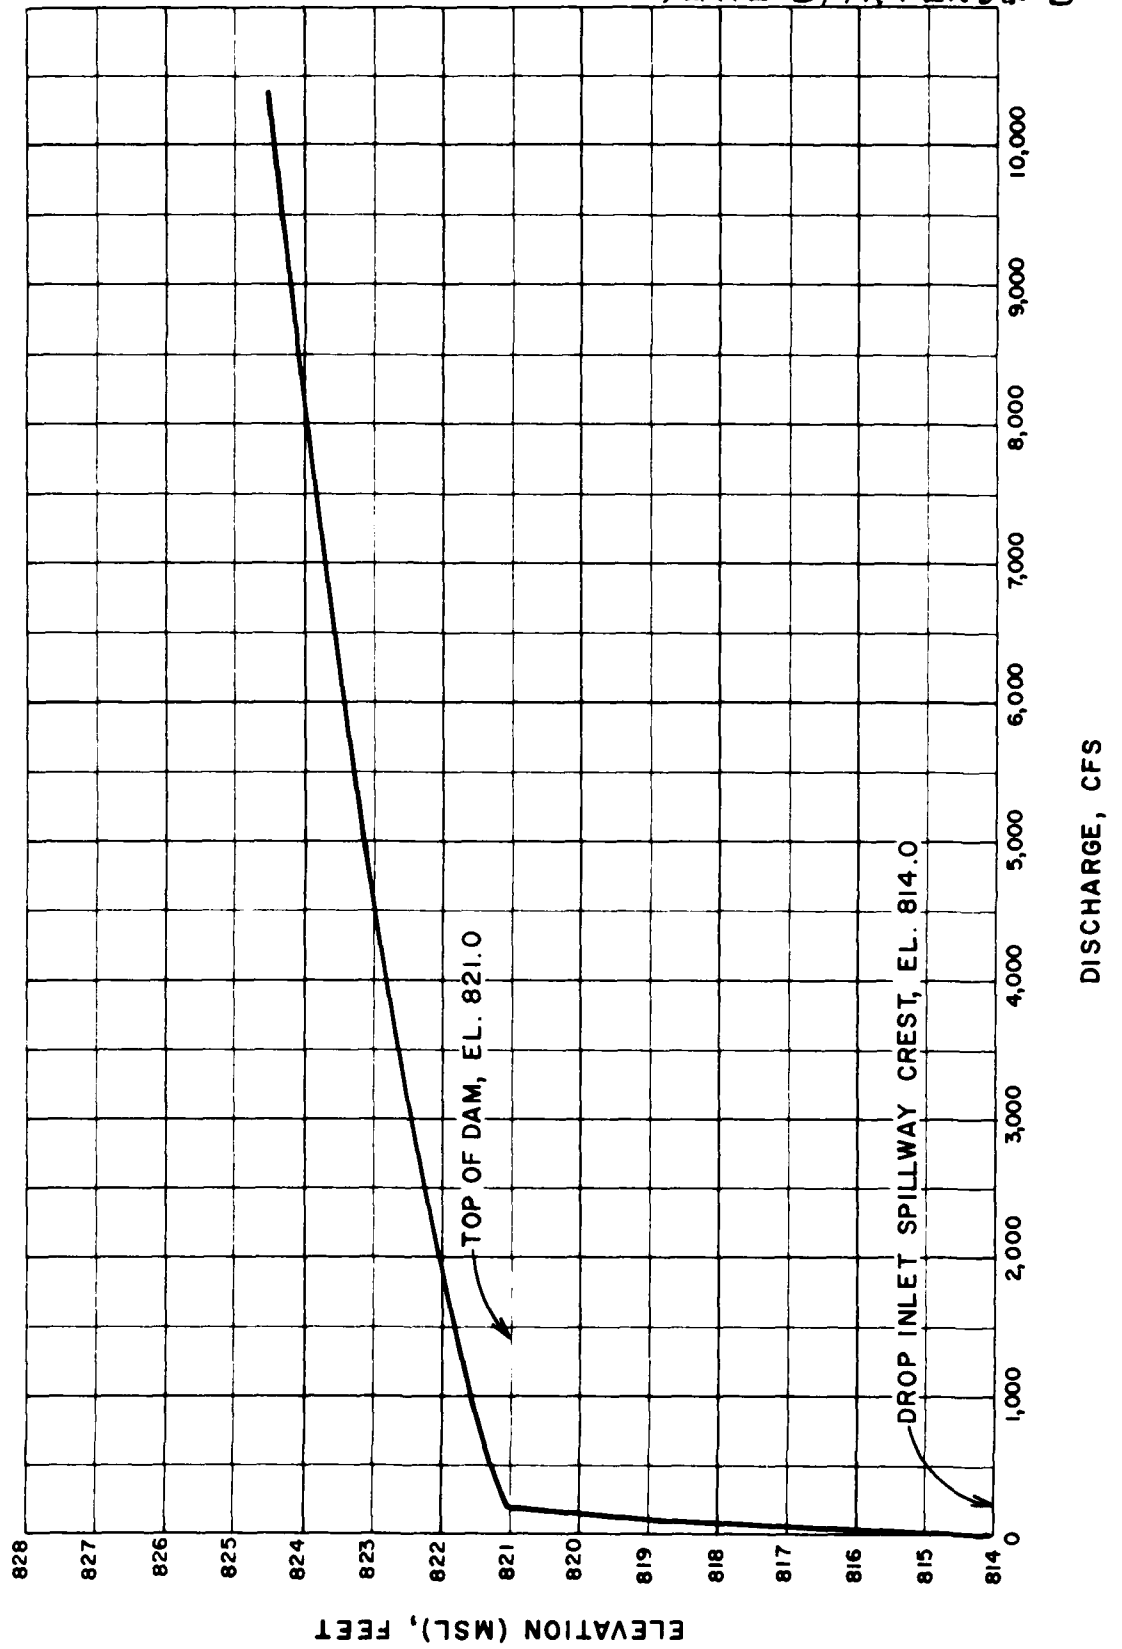
WOODRIDGE LAKE DAM (MO. 11005)  
SPILLWAY & OVERTOP RATING CURVE

The stage-outflow relation for the spillway was prepared from field notes, and sketches, prepared during the field inspection. The reservoir stage-capacity data were based on the U.S.G.S Warrenton Quadrangle topographic map (7.5 minute series). The spillway and overtop rating curve and the reservoir capacity curve are presented in Plates 2 & 3 respectively in Appendix B.
